Fluid Ingression Damage Mechanism in Composite Sandwich Structures

Allison Crockett, Wichita State University
Hal Loken, Consultant
John Tomblin, Wichita State University
July 10, 2007

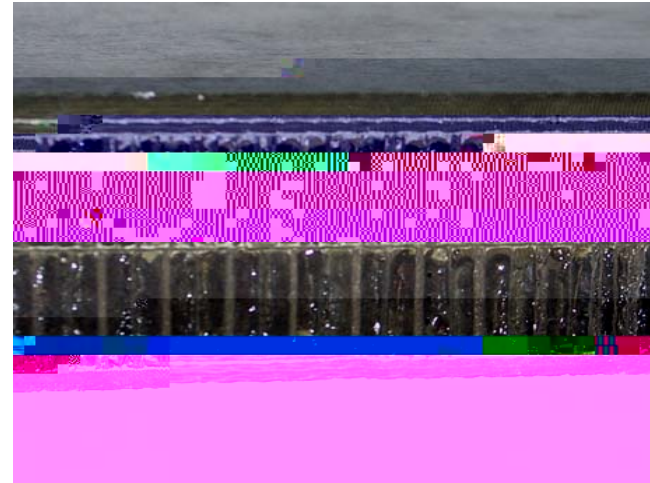
- A320 Elevators
 - Affected Areas: Trailing edge inserts, bonding straps, panel surface.
- A300/A310 Rudders
 - Disbonds between skin and honeycomb cores
 - Water and Skydrol contamination
 - Incorrect repairs, not bonded correctly and excessive paint build-up
- Water ingress leads to
 - Deterioration on the honeycomb/skin bonding line
 - Delamination
 - Weight Increase
